RE: IN THE MATTER OF THE INQUIRY INTO THE OPERATIONAL PRACTICES  
OF LITCHFIELD PARK SERVICE COMPANY (DOCKET NO. SW-01428A-  
07-0602)

RE: LITCHFIELD PARK SERVICE COMPANY – WASTEWATER DIVISION  
FIELD AND OFFICE VISIT ON JULY 10, 2007 (DOCKET NO. SW-01428A-06-0444)

RE: Summary of Litchfield Park Service Company - Wastewater Facility Incidents  
June 20, 2007 through - June 24, 2007

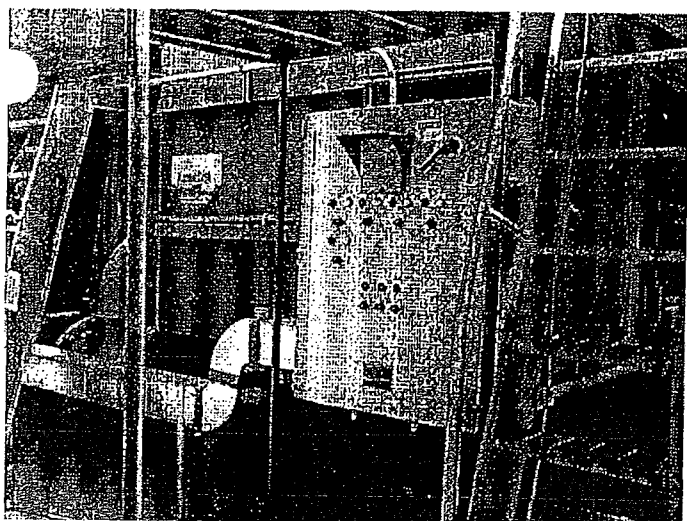
Disk Filter

June 21, 2007 – Around mid-day, the SCADA system notified the plant operator of high level flows into the PVWRF. This SCADA alarm resulted in the finding of a 25,000 gallon spill from manholes behind the Denny’s (same facility as June 20), Wendy’s and Cracker Barrel restaurants and Palm Valley Hospital. Sewage was also spilled onto Litchfield Road from manholes in the street, estimated at 5,000 gallons to 7,000 gallons. This clean-up spill was assisted by the City of Goodyear (“City”) that recovered an estimated 24,000 gallons of the spill. The cause of the spill was due to grease and oil build-up in the disc filters at the PVWRF.

Phase 10 will allow recycling of the influent water to the filters back to the headworks. This change is being implemented in response to the June 2007 wastewater spill which was caused by grease and oil getting past the sequencing batch reactors ("SBRs") and clogging the disc filters. The plant will now be able to recycle the wastewater from the SBRs back to the headworks which will allow the SBRs to reprocess this off-spec wastewater and hopefully prevent the filters from being clogged if this type of event reoccurs.

2. An additional 12" return line from the surge tank to the headworks has been added on a temporary basis and a permanent installation is under design. This will allow cleaning of the surge tank to occur more easily and effectively. It will also decrease the solids load which is passed through the filters.
